444 Cedar Street, Suite 1500
Saint Paul, MN 55101
651.292.4400
tkda.com

Field Report

| Project: | <u>Ivy Falls Street Improvements</u> | Date: | <u>11/8/2021</u> |

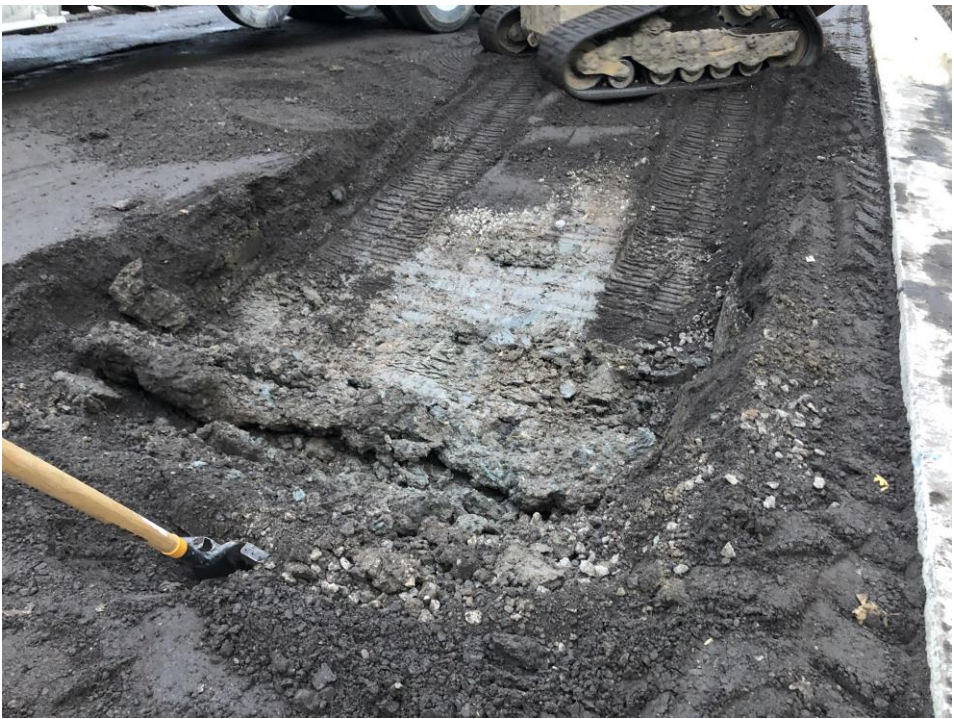
| Photo No. | Date: 11/8/2021 | |

Alcon arrived at approximately 7:00am to warm up machines and begin work on base preparation on Brompton Place. The crew continued to import reclaim material to fill the section. The crew continued to import class 5/reclaim material and roll throughout the day. Around 10:00am, grades were checked approximately 150' in from TH 13 by TKDA. Blue tops were set and the grade was finalized. The crew used blue tops to fine tune the grade before tolerancing. The grade was periodically rolled with both the sheep's foot and smooth drum roller. At approximately 1:30pm the crew watered the grade and rolled with the smooth drum. In the afternoon, the crew worked on adjusting the air vent, cleaning curb with the blower and edging the curb lines. The crew also worked on sub cutting some material near the intersection of TH 13 and Brompton. Soft saturated clay was cut and replaced with imported reclaim material.

| Description: Subgrade correction Brompton | | |
